Case Study: Thermal Roof Inspection at 4037 13th St., St. Cloud, FL

Location: 4037 13th St., St. Cloud FL 34769

Service Provided: Drone Thermal Roof Inspection

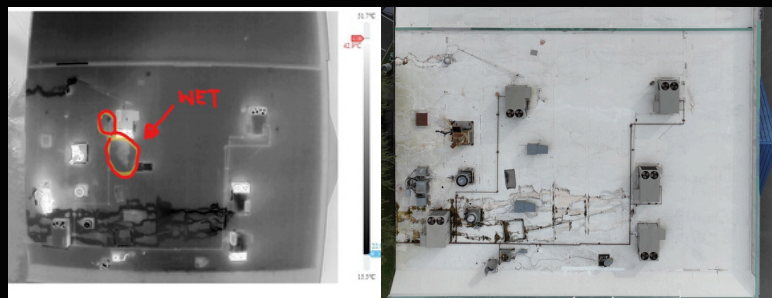
The thermal inspection uncovered a **potential anomaly near a roof HVAC unit**. This area displayed temperature variations that indicated possible moisture buildup. The results of the drone inspection provided Apex Seal Coating with clear data, allowing them to recommend further testing of the specific section around the HVAC unit. This targeted approach avoided unnecessary roof tear-off and limited the repair scope to the affected area, saving the client time and money.

- **Drone Flight Time:** A few hours
- **Findings:** Temperature anomalies near the HVAC unit
- **Next Steps:** Destructive or core sampling of the HVAC-adjacent area, followed by focused repair efforts
